**REMOVAL AND REPAIR OF
EBR-II PRIMARY SODIUM PUMP NO. 1**

**B. C. Cerutti, G. E. Deegan, J. D. Nulton,
W. H. Perry, and R. E. Seever**

EBR-II Project

May 1972

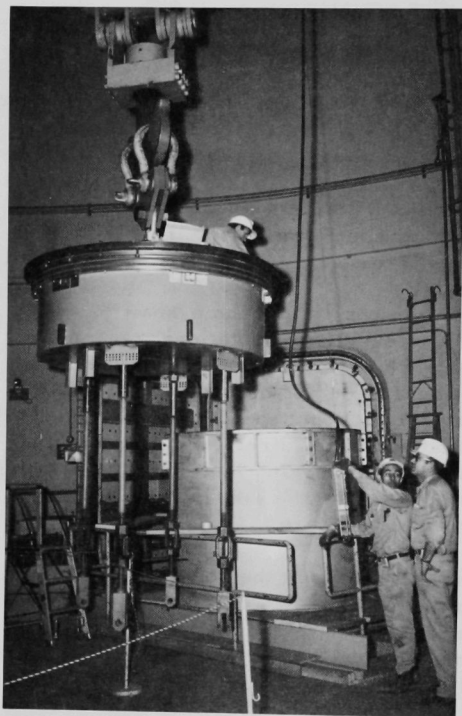
Fig. 6. Primary-pump Removal Equipment.
ANL Neg. No. 103-N5828.

Two piston lifting-rod assemblies (rods, pads, nuts, turnbuckles, etc.) were tested at a time, with the dynamometer used as a load gauge. A 27,000-lb load was applied to each set of rods, representing 125% of the anticipated pump mass to be lifted by each set. Figure 6 shows the silo piston with four attached lifting rods. Following the test, all equipment was disassembled and inspected. No deformation was found.

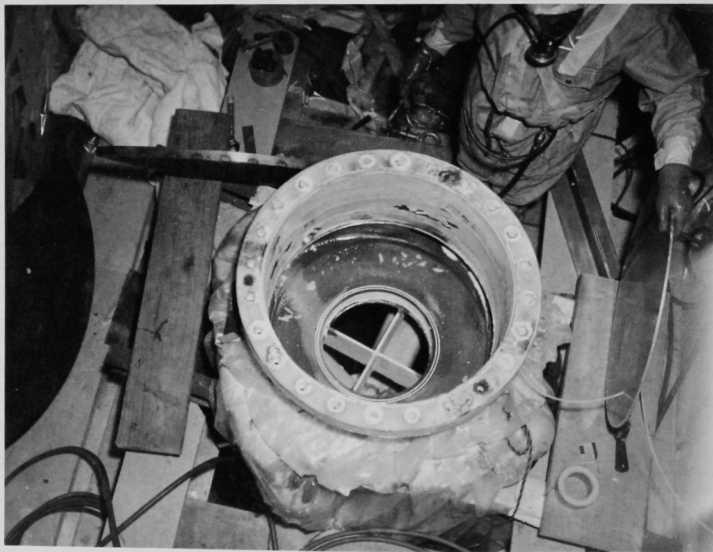
(8) The sump area of the case-manifold was relatively free of sodium and sodium oxide (see Fig. 13).

Fig. 13. Interior of Case-Manifold. ANL Neg. No. 103-O5173.

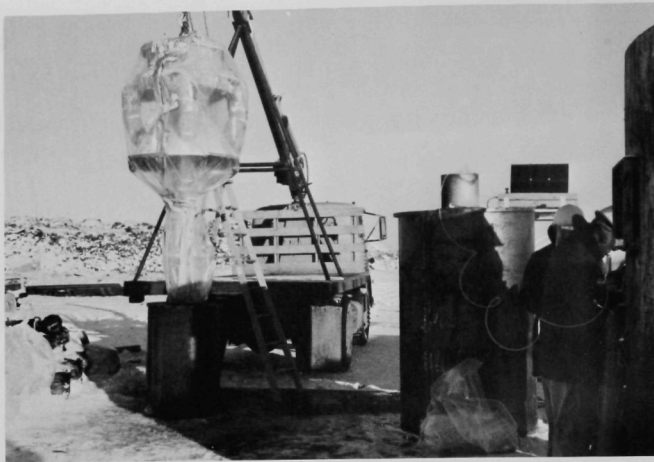
Fig. 15. Sodium Cleaning. ANL Neg. No. 103-O5220.

Sodium cleaning of the pump subassemblies was accomplished by placing fabricated cleaning tanks on the front section of the pad and installing an argon supply line to discharge inside the tank bottoms throughout the entire cleaning process. The argon was permitted to fill the tanks, and then the pump subassemblies were placed inside the tanks by using the boom truck. The polyethylene wrapping was removed from the pump subassemblies as they were lowered into the tanks. Vented metal tank covers were then placed on the tanks and the tanks were filled remotely with ethyl alcohol through the drains. The alcohol was gradually diluted to a 50-50 alcohol-water mixture during the soaking until all sodium reaction had ceased. The diluted alcohol was then drained out of the tanks and the pump subassemblies were hot-water-washed in the tanks, lifted out and covered with polyethylene, and held for decontamination (see Fig. 15).

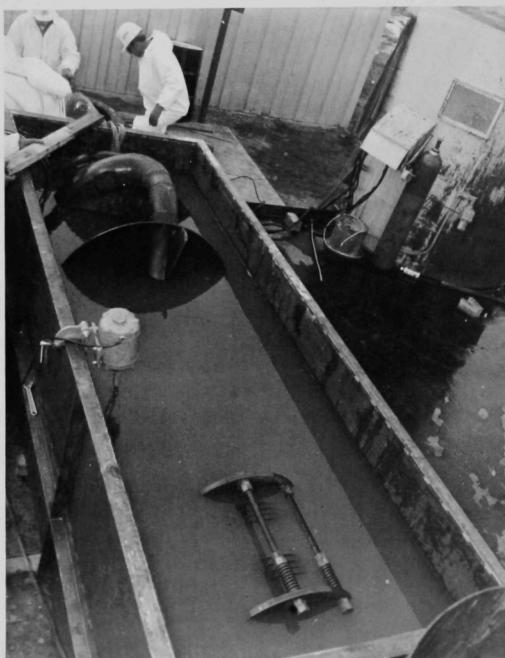
Fig. 16. Radioactivity Decontamination of Case-Manifold.
ANL Neg. No. 103-O5543.

Partial decontamination of the pump subassemblies was accomplished by soaking them in the tanks that were used for sodium cleaning. The tanks were washed, an argon supply was installed in the tanks, a Turco No. 4521 decon solution was mixed in the tanks, and the pump subassemblies were submerged in the decon solution (see Fig. 16). An agitator was installed in the tank for the case-manifold to provide adequate circulation.

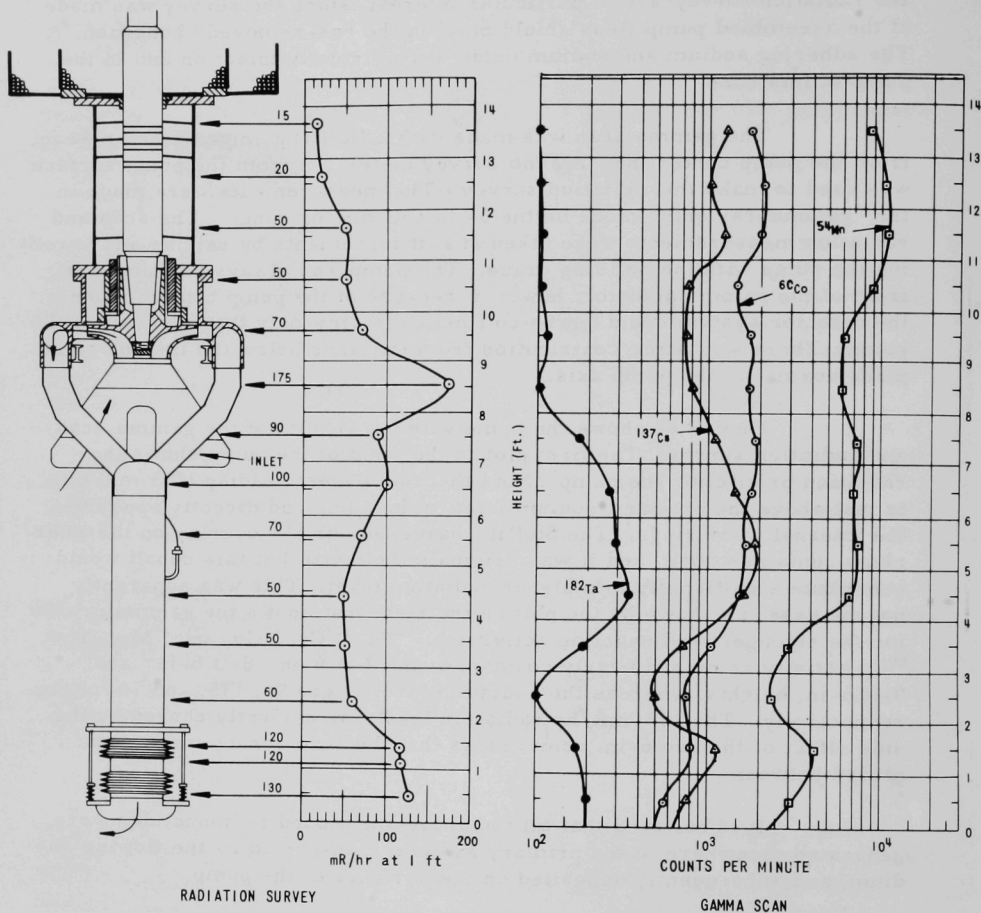
Figure 17 shows the pump with the results of the gamma scan and radiation survey. The first plot to the right of the pump shows the radiation profile for the pump. Note that the highest reading (175 mR/hr) is just above the primary-sodium inlet to the pump and directly opposite the internal wear rings. The Stellite-hardened surface overlay on the wear rings contains cobalt, and it was originally believed that this cobalt would contribute significantly to a higher radiation level. This was apparently not the case, as shown by the plot on the right that shows the gamma profile for the strongest radionuclide activities, ^{182}Ta , ^{137}Cs , ^{60}Co , and ^{54}Mn . The ^{60}Co activity remained nearly constant at the 7-ft 6-in., 8-ft 6-in., and 9-ft 6-in. heights, whereas the radiation levels were 90, 175, and 70 mR/hr, respectively. The 175-mR/hr radiation level was evidently caused by the side effect of the two 6-in. volute pipes that the Juno survey meter was placed between.

Fig. 17. Radiation Survey and Gamma Scan of Primary Pump before Cleaning and Decontamination. ANL Neg. Nos. 103-O5809 Rev. 1 and -O5810 Rev. 1.
